## Service and Warranty Reference Library

Date: 12/20/02

Code: 632

### Reference: Addressing Customer Complaints of Popping Noise from Front Suspension, M1999-2002 9-3 Sedans, M1999-2003 9-3 Convertibles

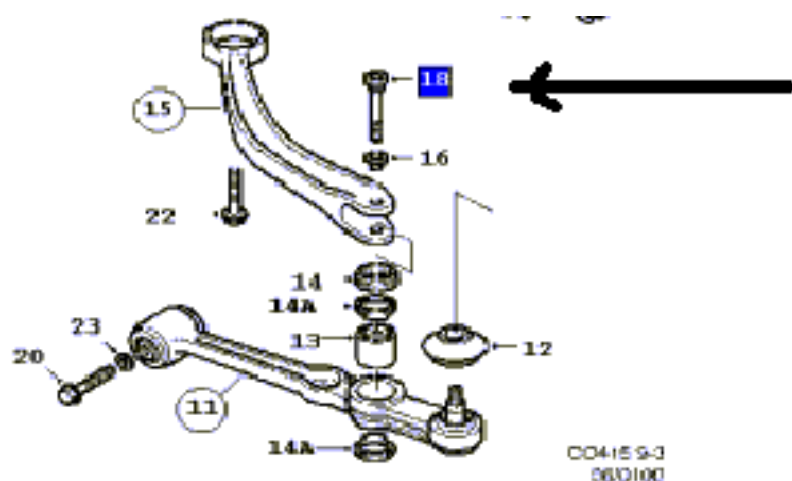
A customer complaint of a popping noise heard from the front suspension on acceleration or deceleration should be addressed by re-torquing the front suspension bolts. Bolt #18 in the below drawing can be re-torqued using essential tool 89 96 894.

Proper torque for this bolt is 44 ft lb (60NM) + 90 degrees.

Note: The surface between the screw head and the stanchion must be lubricated with Vaseline before re-torquing.

Bolt #22 in the drawing below should be re-torqued to 81 ft.lb (110 NM) + 75 degrees.

NOTE: Front suspension bolts must not be overtorqued. Bolts that have been overtorqued must be replaced.
