# CONV. TOP FABRIC WEAR: NEW PARTS & ADJUSTMENT

1992 Saab 900

## MINIMIZING TOP FABRIC WEAR

Bulletin No.: 09/93-0369

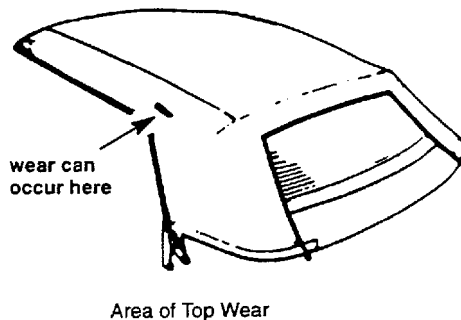
94D51915

When the car is driven with the top down, a certain amount of wear may occur in the top fabric. See Fig. 1. This is because the eccentric screws, for adjusting the parking position of the top when it is raised, come into contact with the top fabric. i.e. The position in which it stops before the latching hooks are hooked into place. On cars VIN M7018385 and later, the eccentric screws are repositioned lower down at the top mechanism retaining brackets. See Fig. 3. This eccentric screw adjustment was done in order to help prevent wear in the top fabric from occurring.

Fig. 1: Area of Top Wear

Spacers are not Factory installed, but it may be necessary to install the spacers even if the eccentric screws have been properly adjusted, regardless of position or VIN in order to minimize wear and ensure optimum top mechanism clearance.

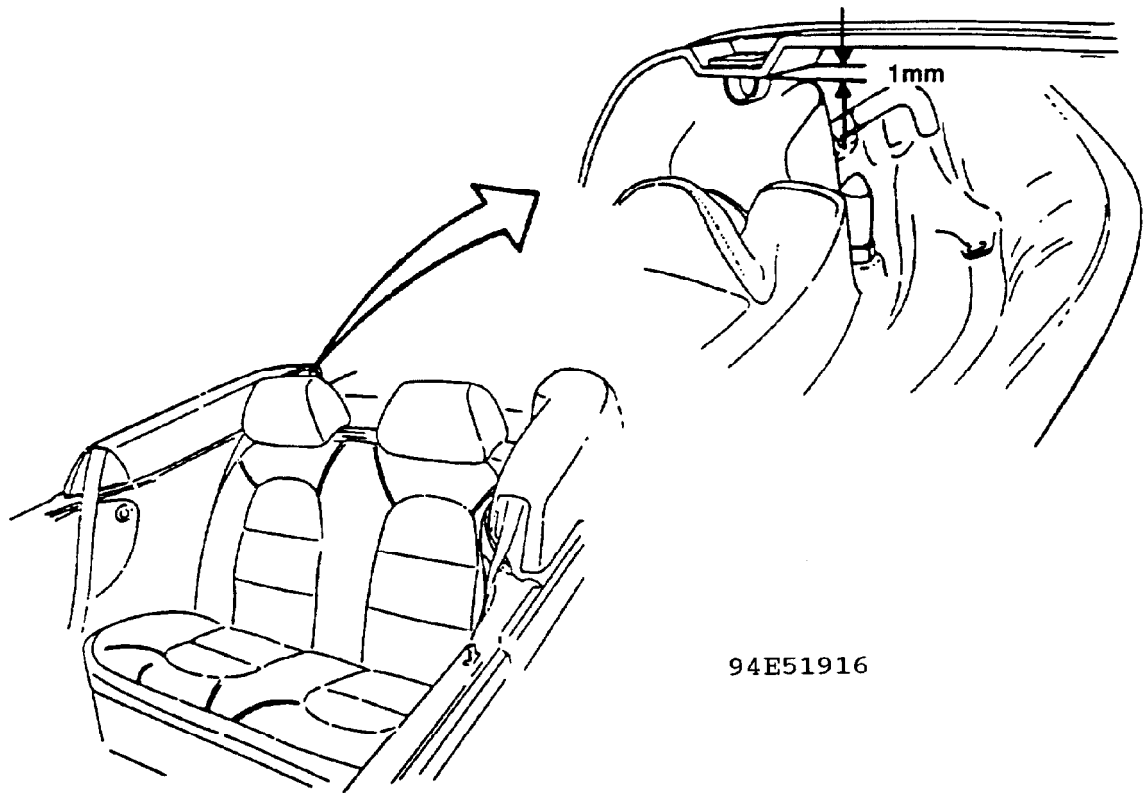
94E51916

Fig. 2: Convertible Top Adjustment

- 1. Lower the top fully. Fold the top fabric behind the rear seat, making sure that the top rests on the stops and does not hang from the seat backrest.
- 2. Fit the side pieces of the hard boot cover in place. Adjust the top stops so that the top mechanism comes as high up as possible without touching the side covers. Adjust The Top So That It Rests 1mm From The Bottom Of The Side Covers. See Fig. 2.

Adjust the top so that it rests 1 mm from the bottom of the side covers.

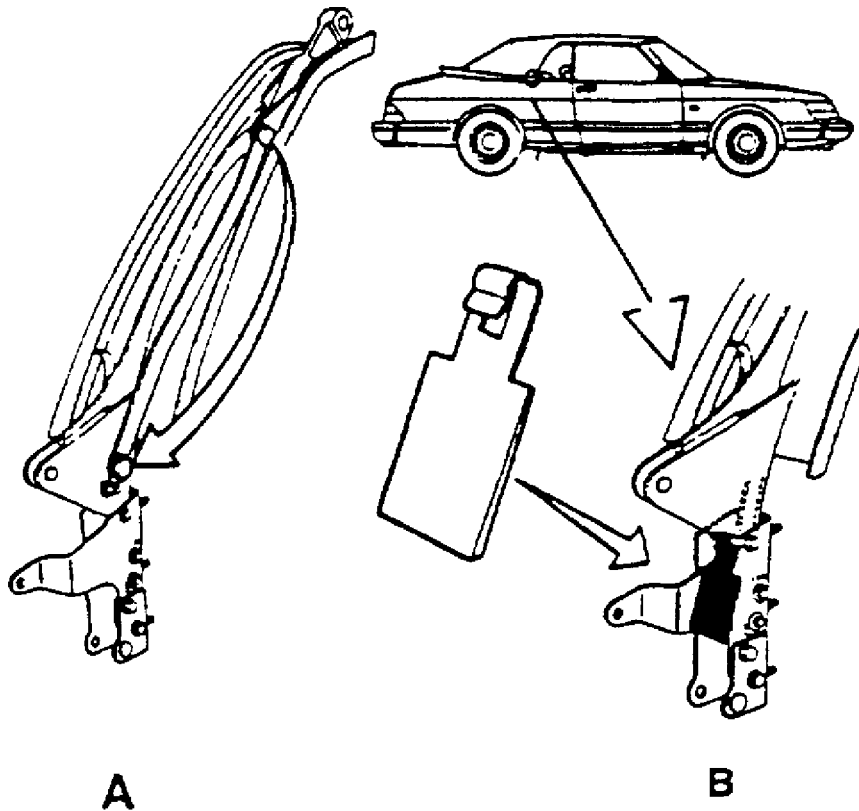
94F51917

Measures to help minimize the Convertible top wear at the area indicated: A) The eccentric bolt has been moved in production and, B) A spacer is available

Fig. 3: Measures to Help Minimize Convertible Top Wear

On all cars, a spacer. Part Number 41 54 787, can be fitted at the top mechanism's stop position when the top is lowered. See Fig. 3. When these spacers are fitted, the fabric is not folded as tightly and does not come into contact with the eccentric screws, thus preventing further wear.

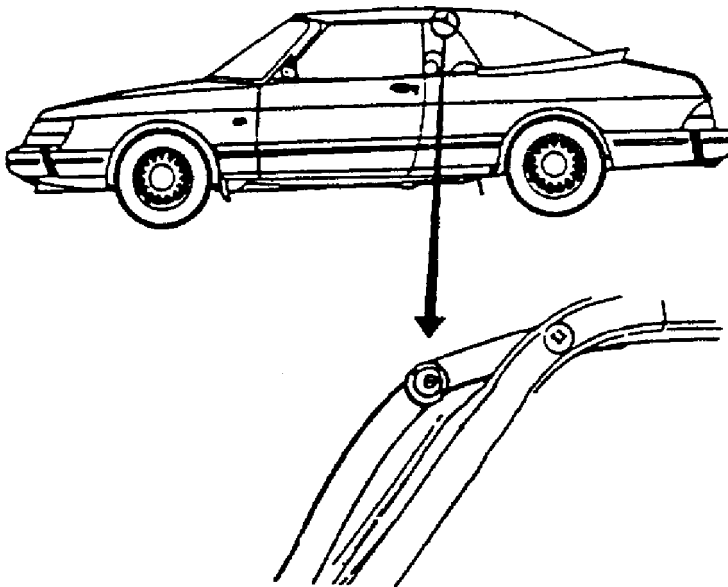
**94G51918**

Fig. 4: Removing Burrs from the Eccentric Bolt

3. Remove any burrs or rough edges on the outside of the eccentric bolt. See Fig. 4.

**Remove any burrs from the eccentric bolt.**

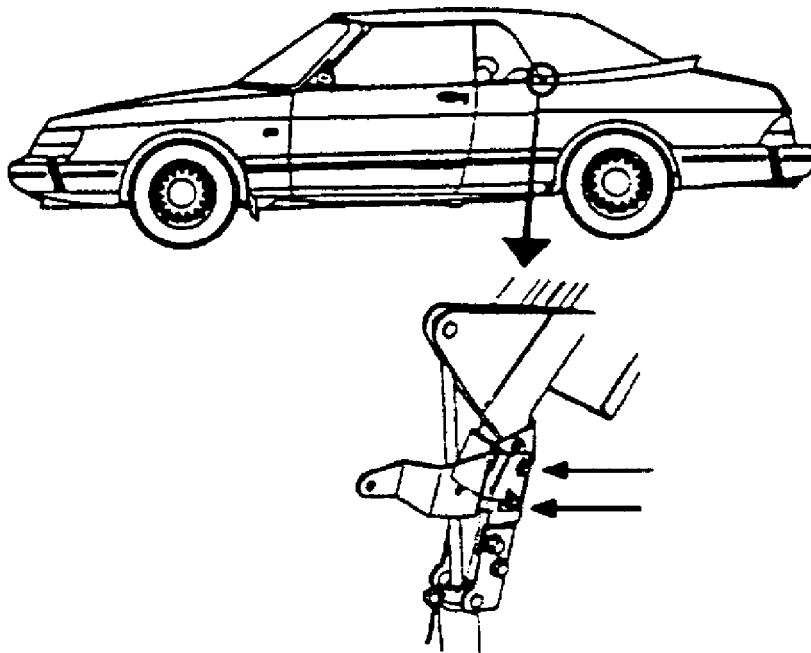
### 94H51919

Fig. 5: Loosening Retaining Bolts for Top Lowering Stop Both Sides

Loosen the retaining bolts for the  
top lowering stop on both sides.

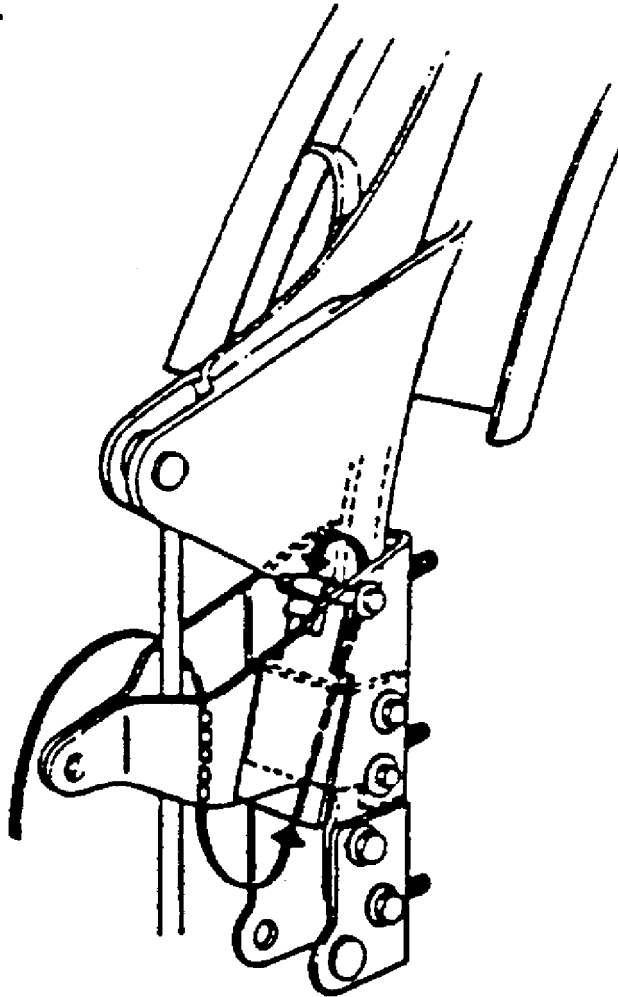
94A51920

Fig. 6: Installing Spacer into Lever Arm

6. Fit a spacer, Part Number 41 54 787, in place. See Fig. 6. The hook opening must face the rear of the car. A clicking sound should be heard as confirmation that the hook has snapped into position. Repeat this procedure on the other side.

**NOTE:** Spacers should be installed between the lever arm and bracket: not on the backside of the bracket. The purpose of the spacer is to maintain a minimum clearance between the lever arm and bracket.

**Install the spacer as shown.**
