# CONV. TOP WATER & WIND LEAKS: NEW PROCEDURE

1992 Saab 900

### CORRECTING WATER AND WIND LEAKS

Bulletin No.: 06/93-0350

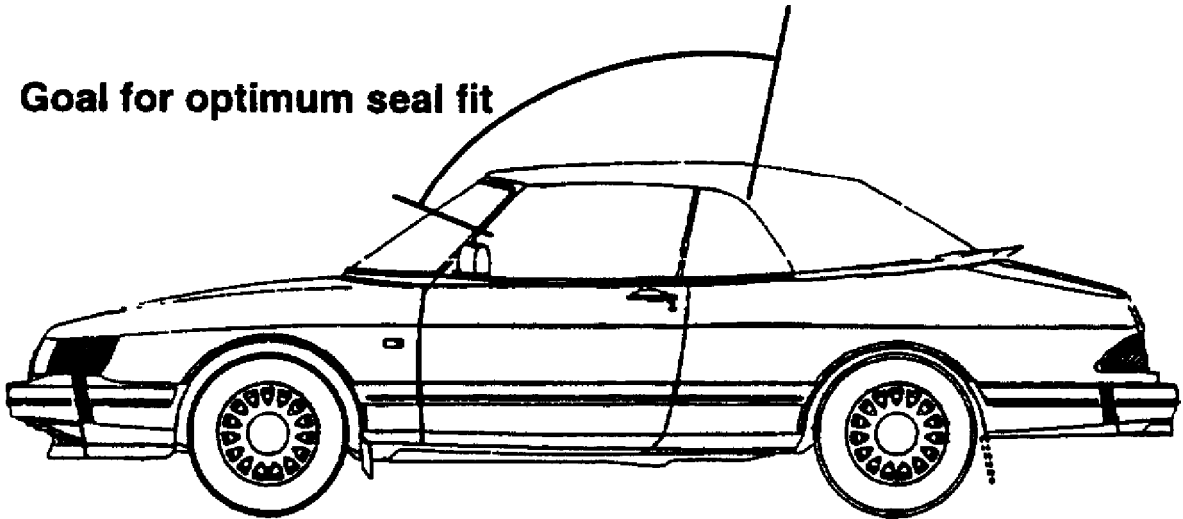
Fig. 1: Section/Area to Aim for Optimum Fit

As a general guideline, all adjustments should take place on the largest body parts first, working from the front of the car to the back. The ultimate goal is for the top seal to fold around the side glass edge on as long a section on each side as possible without altering the seal alignment in a detrimental manner. See Fig. 1 & 2. Please note that this will be difficult to achieve on the entire length of the side glass on all cars due to differing body measurements.
